Report of
**Comprehensive
Asbestos Survey**

Building Surveyed:
Oak Hollow Office
5901 Boca Raton
Fort Worth, TX 76112
(Oak Hollow Office)

Report Date:
Monday, July 09, 2007

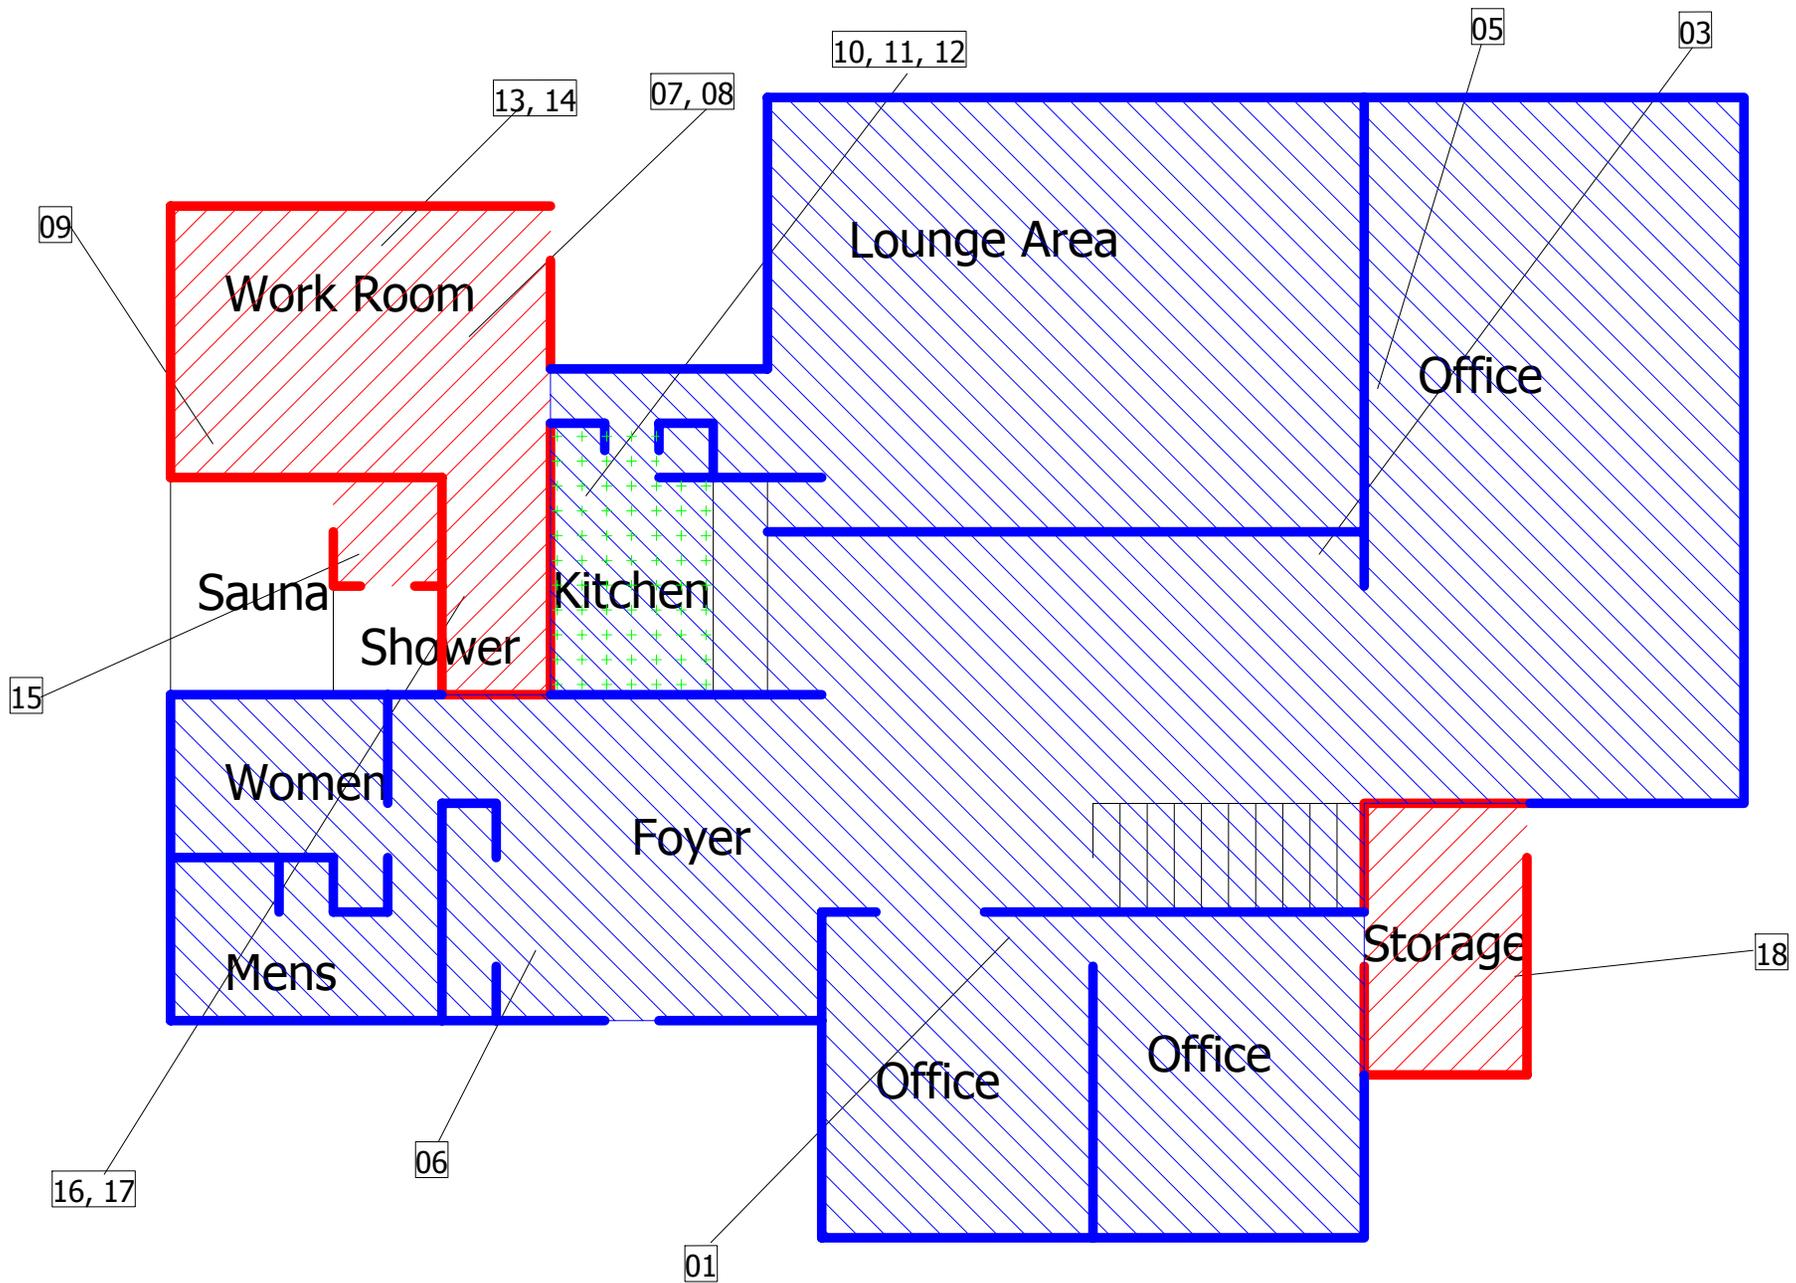
Downstairs

- Beige Sheetrock walls with joint compound
- Beige Sheetrock ceiling with joint compound
- White Sheetrock walls with joint compound
- White Popcorn ceiling
- 9x9 Floortile

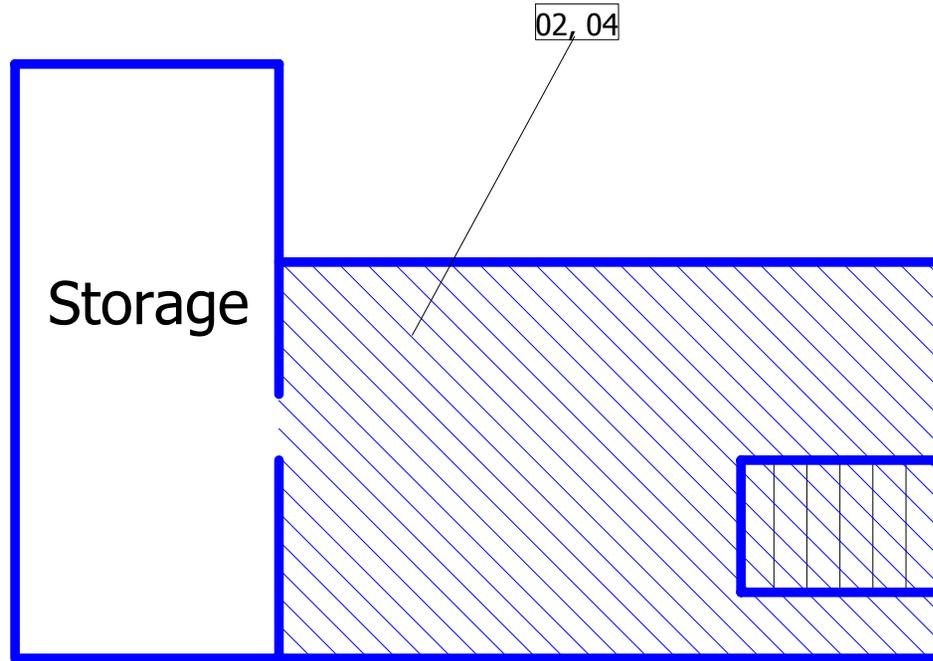
Upstairs

White Sheetrock walls with joint compound
-

White Popcorn ceiling
