*Report of*  
**Comprehensive  
Asbestos Survey**

*Prepared for:*  
**City of Fort Worth**  
1000 Throckmorton  
Fort Worth, TX 76102

*Building Surveyed:*  
**Oak Hollow Office 2**  
5901 Boca Raton Blvd  
Ft. Worth, TX 76112  
*(Oak Hollow Office)*

*Report Date:*  
**Wednesday, November 28, 2007**

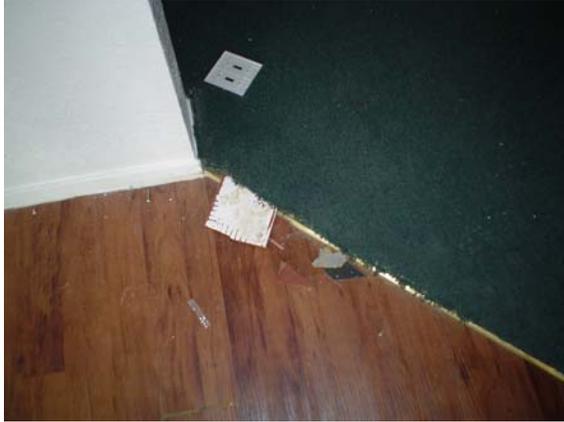
Grout (White) (Under Ceramic Tile): Great Room; Qty: 705 s.f.

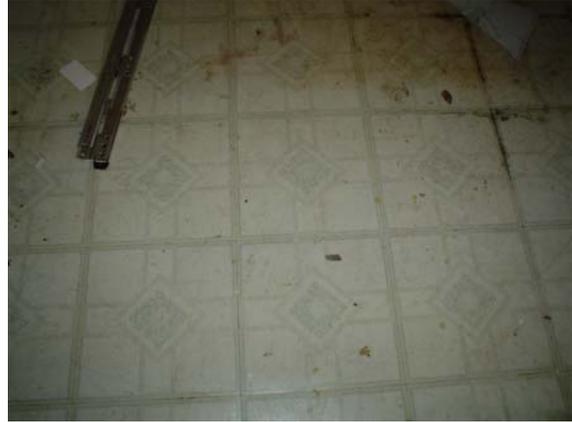
Peel and Stick Flooring (White/Blue Pattern) and Mastic (Brown): West Storage Office, Kitchen; Qty: 240 s.f.

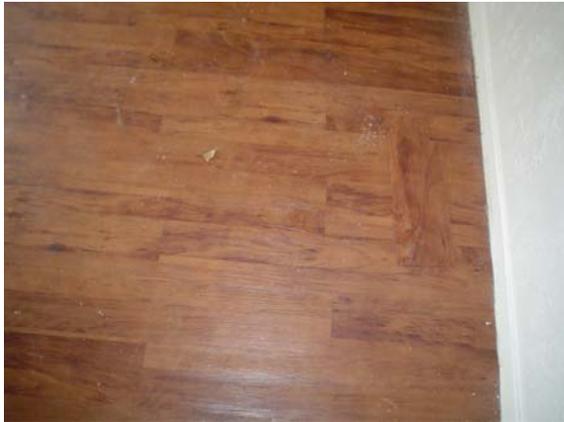
Peel and Stick Flooring (Wood Grain) and Mastic (Brown): Entry, SE Office; Qty: 250 s.f.

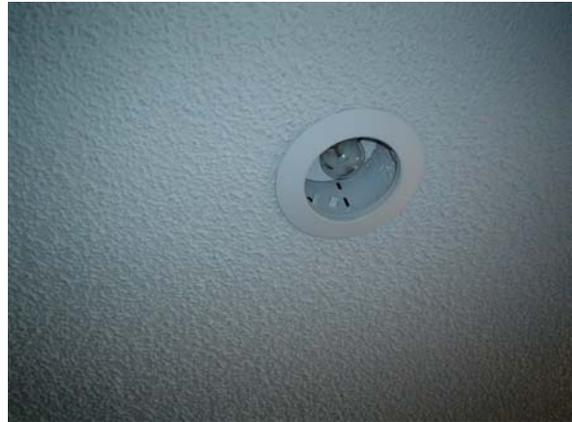
Sheetrock wall and ceiling covering in good condition presents a low potential health hazard to building occupants due to its observed good condition and intact binding matrices. Prior to building demolition, renovation or work activities that would disturb these materials, removal must be performed by a properly trained and licensed abatement contractor.

Popcorn Ceiling Texture: SE Office, Women's Restroom, Hall by Kitchen, Upstairs; Qty: 2200 s.f.

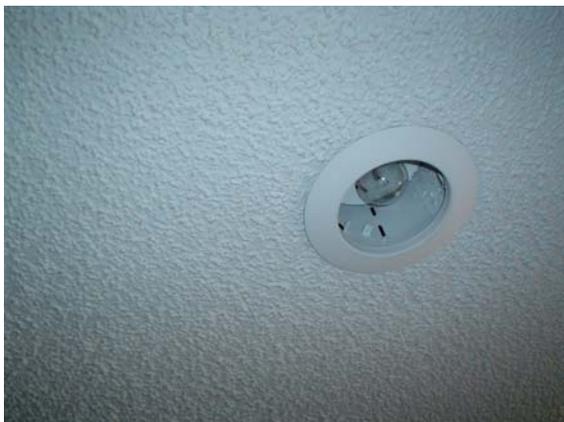
Popcorn Ceiling Texture: SE Office, Women's Restroom, Hall by Kitchen, Upstairs; Qty: 2200 s.f.

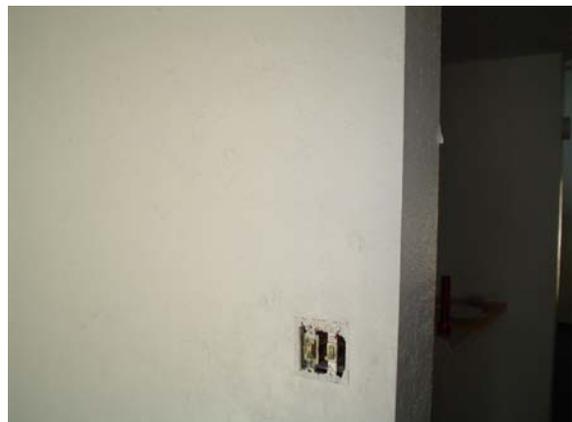
Wall Texture: N. Wall Entry, SE Office, W. Wall Great Room, NE Office, Upstairs W. Wall; Qty: 5700 s.f.
